# NORDIC SHOTCRETE

## FINAL REPORT

CONCRETE REHAB PILOT PROJECT  
WHARF FJORDGATA  
2018–2019

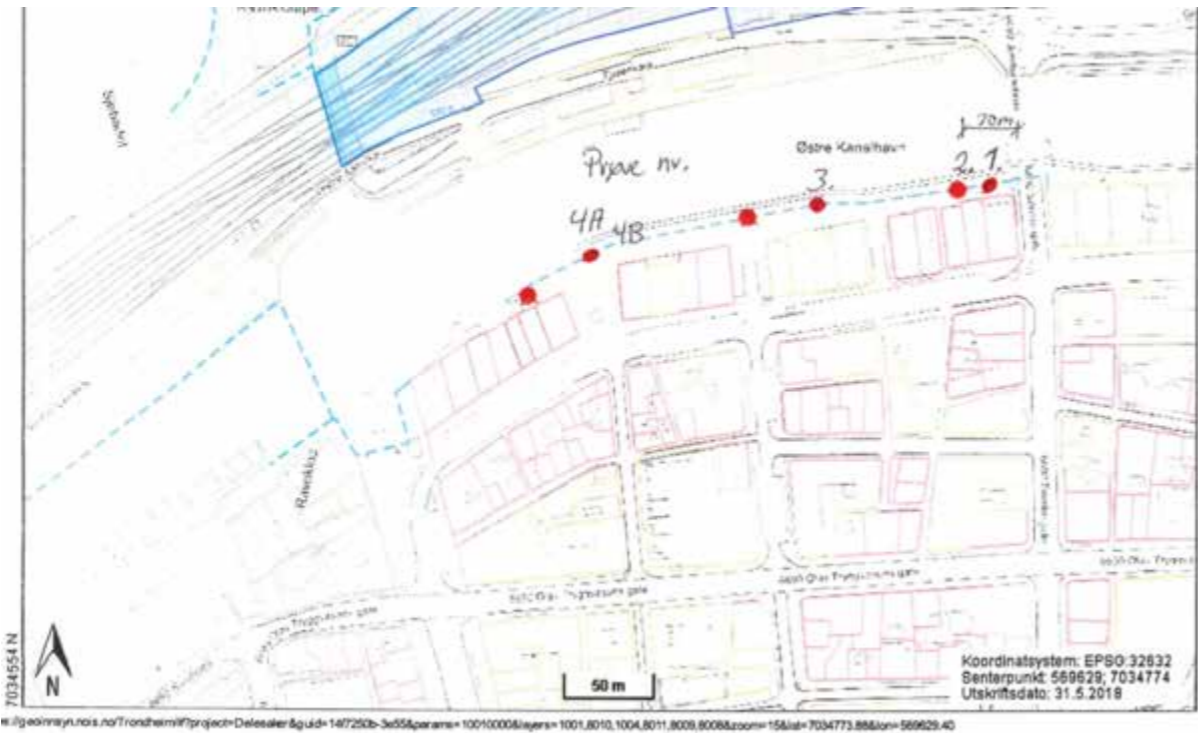
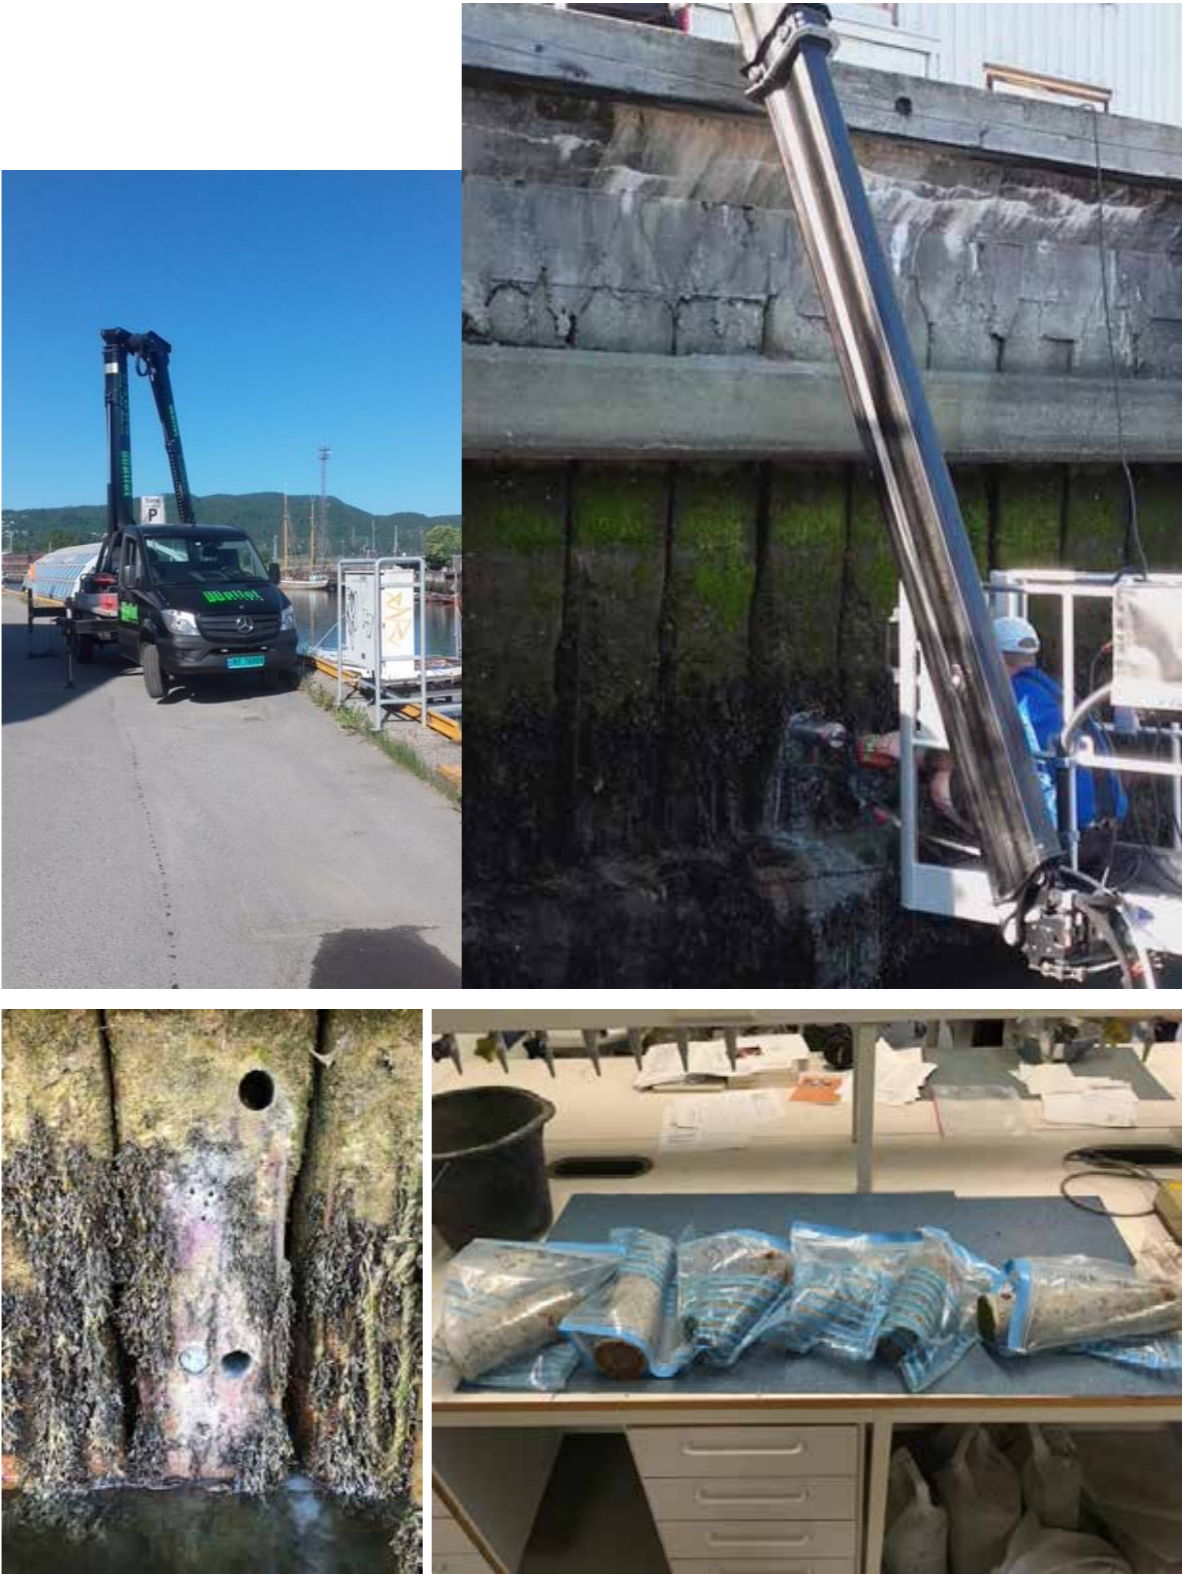
1.3 Collection of core samples, compressive strength, spring 2018

Concrete has good strength, and the corrosion of reinforcements inside the concrete is minor. The concrete surface is degraded, severely in some places, primarily due to external chemical weathering, as well as some frost damage.

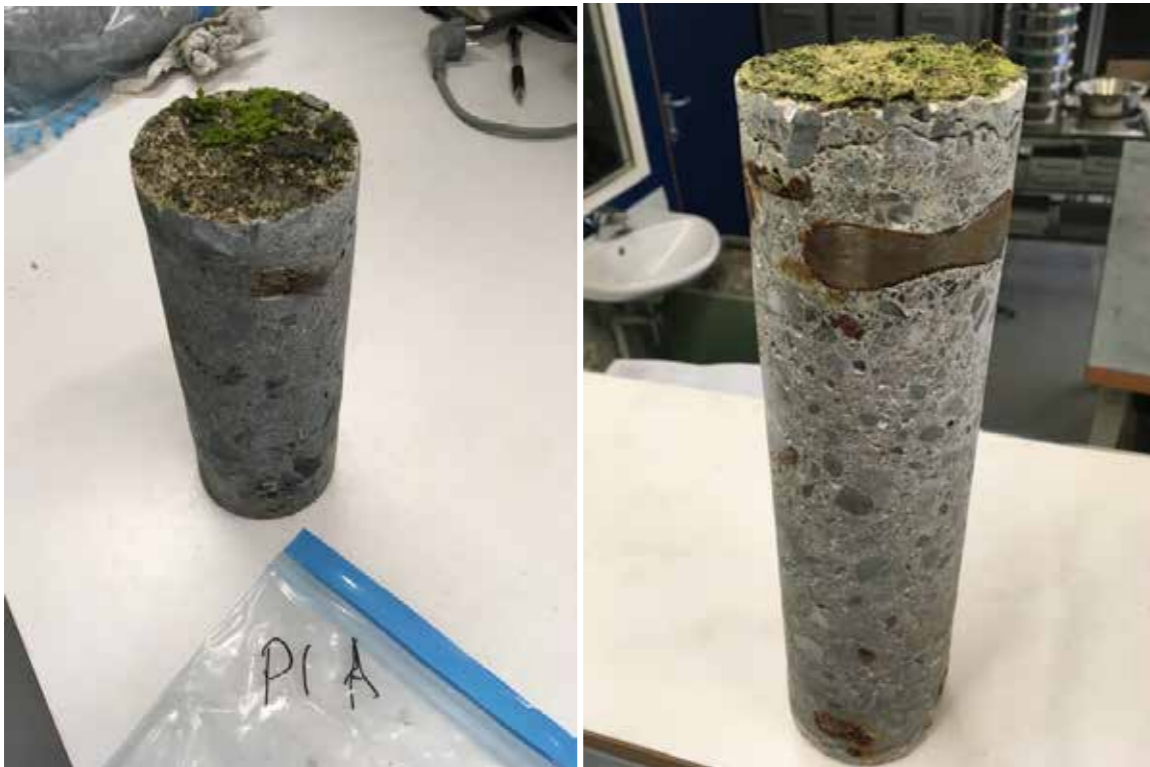
Sample 1A. Nice homogeneous concrete, well-proportioned. Minimal cracking, minimal damage. Good impression of sample.

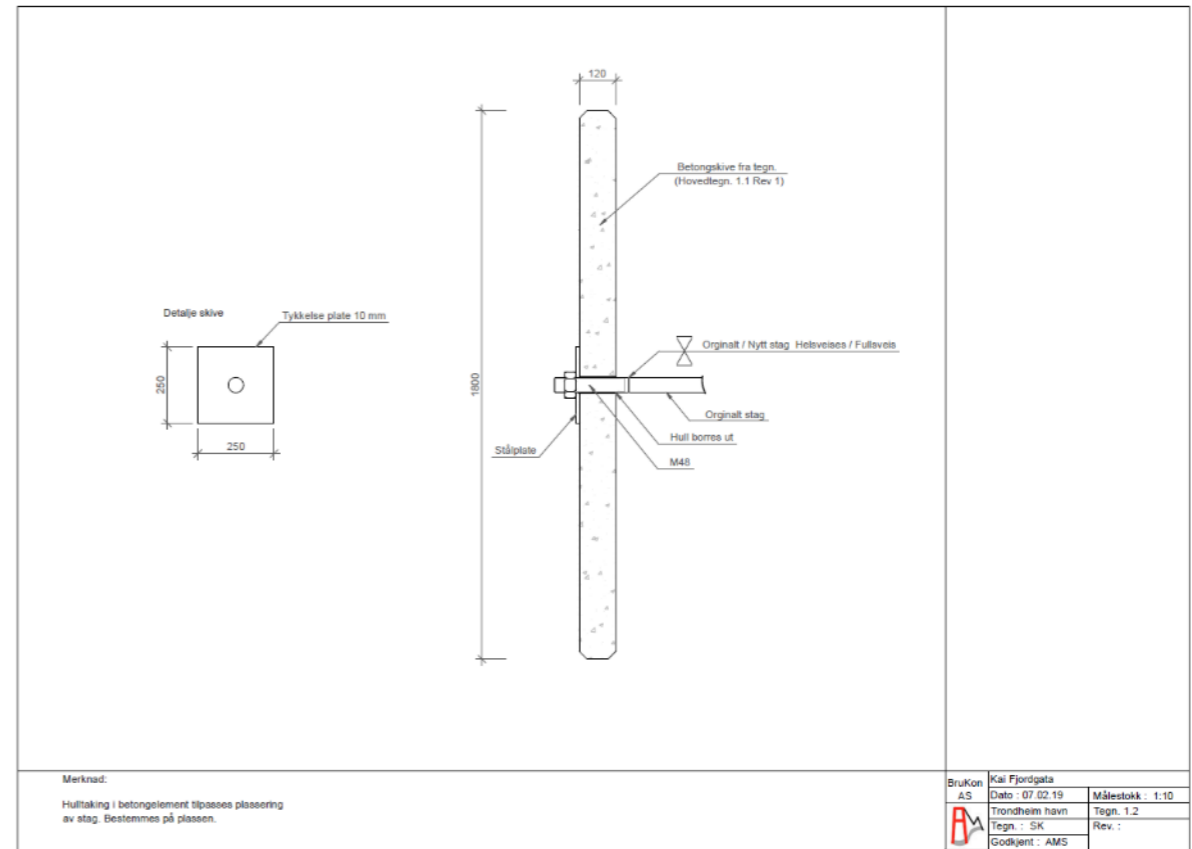
Reinforcement not shown in image, but reinforcement has been added in both the vertical and the horizontal direction. Additional reinforcement in the area near the bolt.

The final solution called for reinforcements in both directions, allowing for the distribution of the point load from the anchors to be distributed across a larger surface. The planning also took into account a potential horizontal displacement, to adjust the holes to the tendons on site. All concrete elements were therefore reinforced with this in mind. See also image below, for additional reinforcement, which would fill the same space as the existing *Larsen profile* of the original solution. This means that our solution has the same (or greater) load-bearing properties as the original solution. The bolted connection has a greater capacity than the original anchoring solution. The bolt has greater tensile properties than the original tendon.

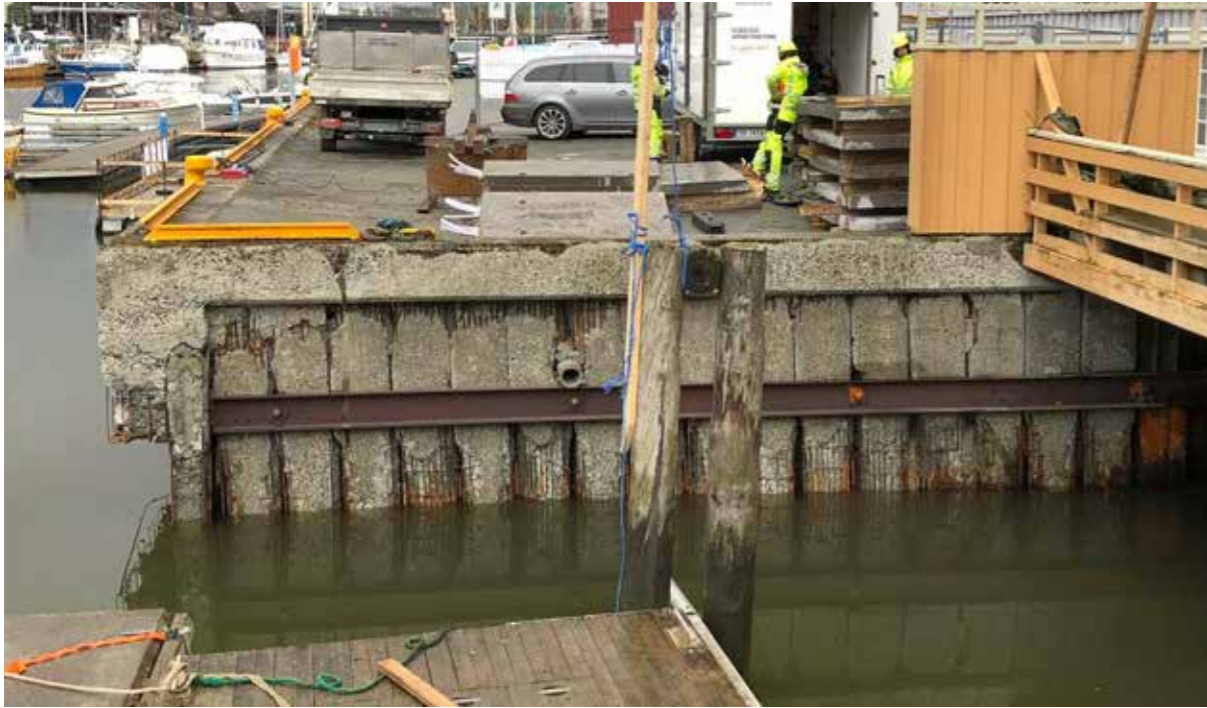
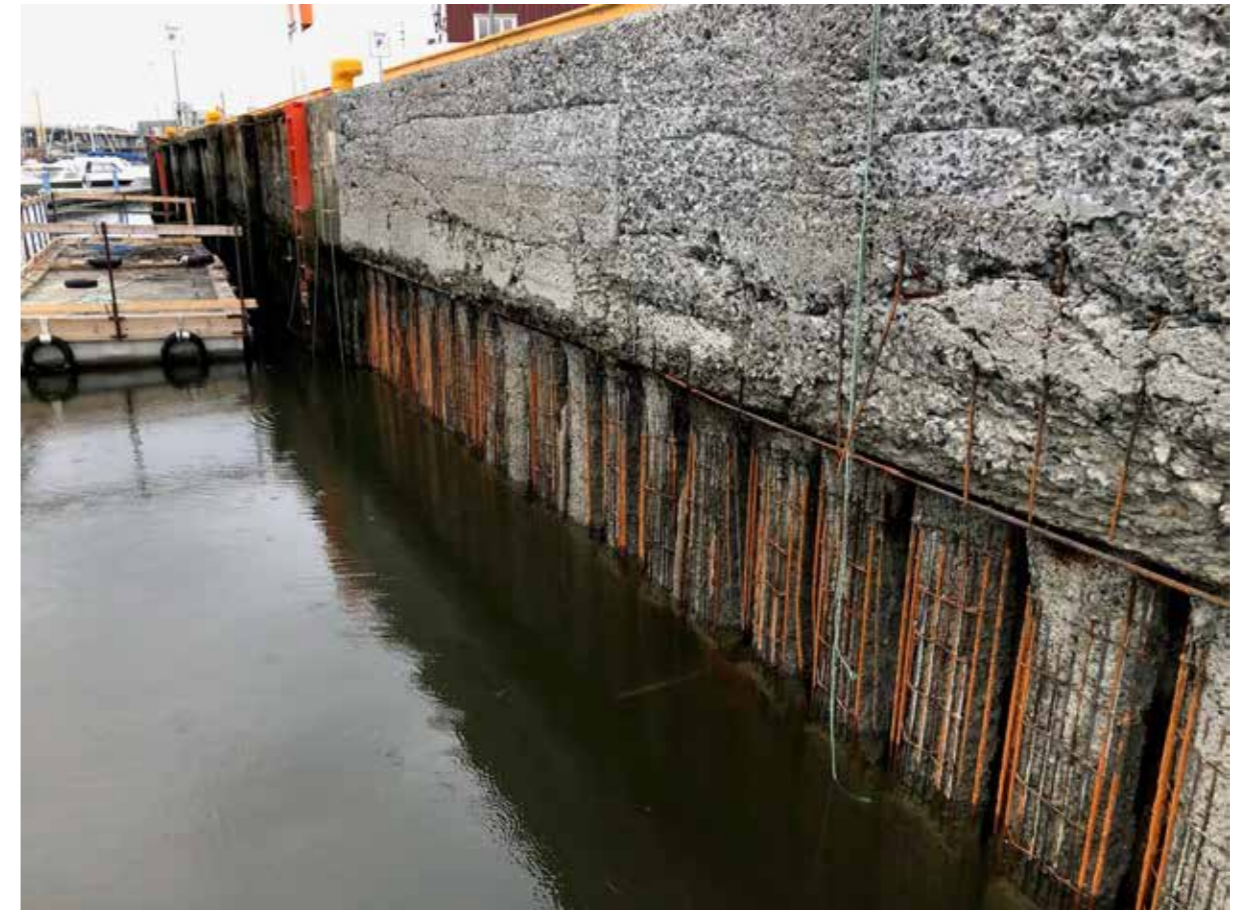
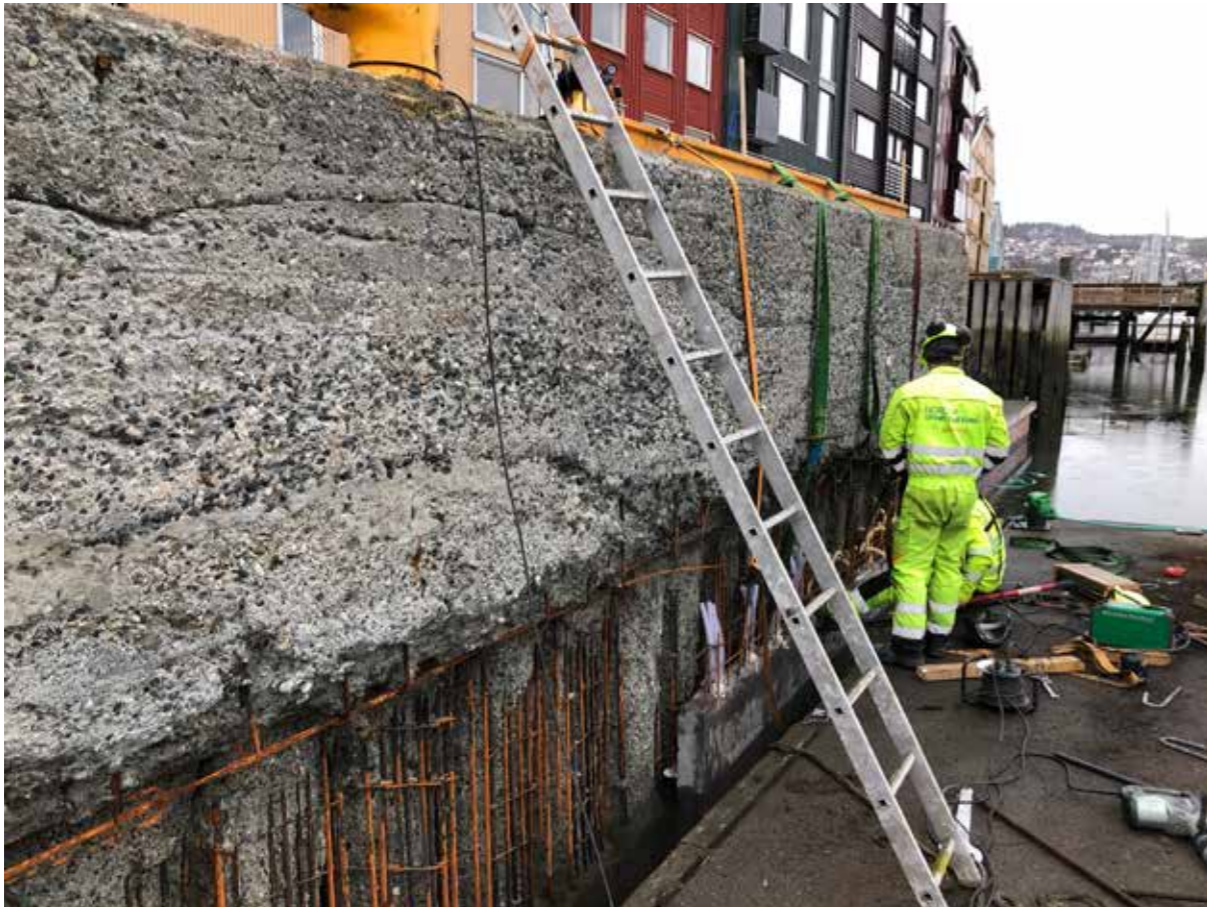
## 11. Finished water-blasted surface

The concrete that was hydro-blasted was in general of good quality, homogeneous/well-composed stone fraction. The concrete surface on the edge beam was eroded and affected by mechanical wear over time. Samples were collected, and the finished hydro-blasted concrete surfaces of both the edge beam and the pile were checked for signs of delamination. There were no indications of delamination or other damage behind the hydro-blasted surface. The concrete in both the beam and the concrete piles was of good quality. We observed pouring joints from the actual construction of the concrete wharf. The concrete pile was eroded, in some areas quite severely in hollows and the tidal zone.

The reinforcement revealed after hydro-blasting was also of good quality. What had not corroded away was largely intact, but very minor damage! The reinforcement showed local damage/pitting. It was therefore quite straightforward to replace the reinforcement that had corroded away in the years that had passed. New reinforcement, B500NC. New reinforcement was installed with overlap, and mesh reinforcement was installed on the outside. This mesh was bolted to the original concrete with strong grip/strength. Surface rust on the hydro-blasted reinforcement was removed by the alkaline formation water when the concrete was applied. There was no accumulation of fouling/kelp, etc. in the period between hydro-blasting and shotcrete application. Consequently, new surface rust on the hydro-blasted reinforcement is not a concern in terms of the residual life of the measures performed.

Where reinforcement has corroded away/is missing, replace with same reinforcement dimension as original.

The bottom beam, the current “Larsen profile”, is so severely corroded, that it will be rebuilt with reinforced concrete. Horizontal reinforcement, 4Ø16, will be added, forming a longitudinal beam absorbing the same loads as the original “Larsen profile”.

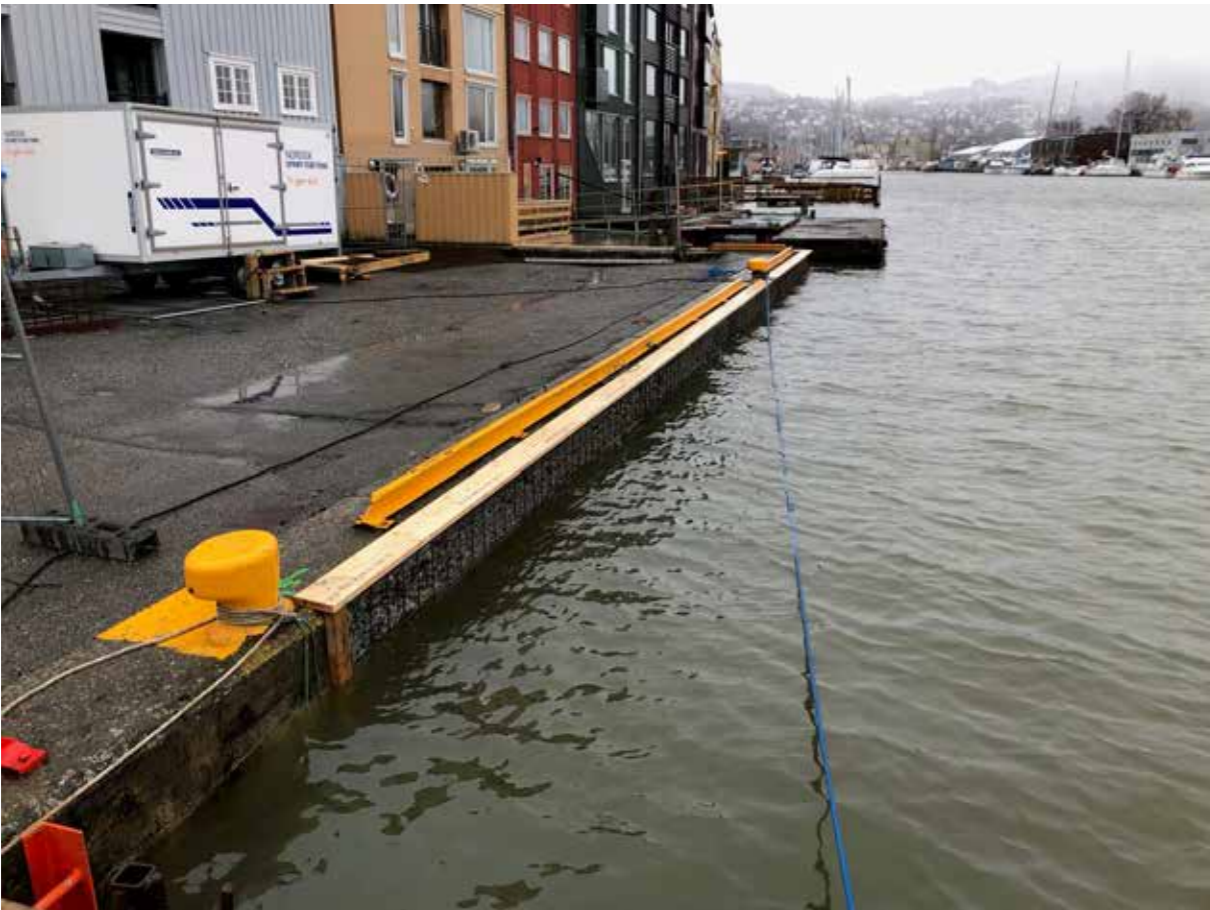
Challenges with large tidal range.
